PEEBLES HIGH SCHOOL PARENT COUNCIL

PHS Buildings Sub-Group

Visits to New Secondary Schools in Scotland – February 2023

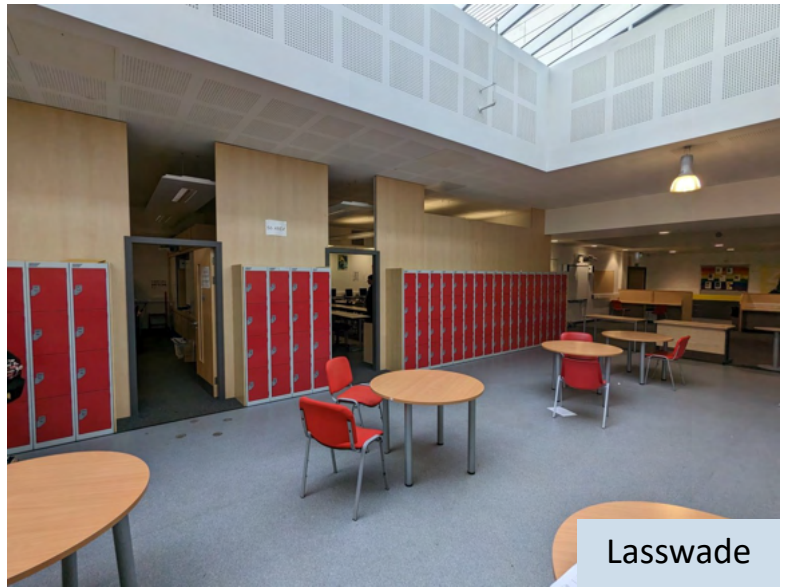
Lasswade

- All classrooms (with the exception of two) have solid walls and doors with a long window next to the door for light.
- Had initially included a few open area seating zones, or break out areas next to classrooms. In two cases, these walls were blocked up 1 year after opening.

Doors with partial glass wall

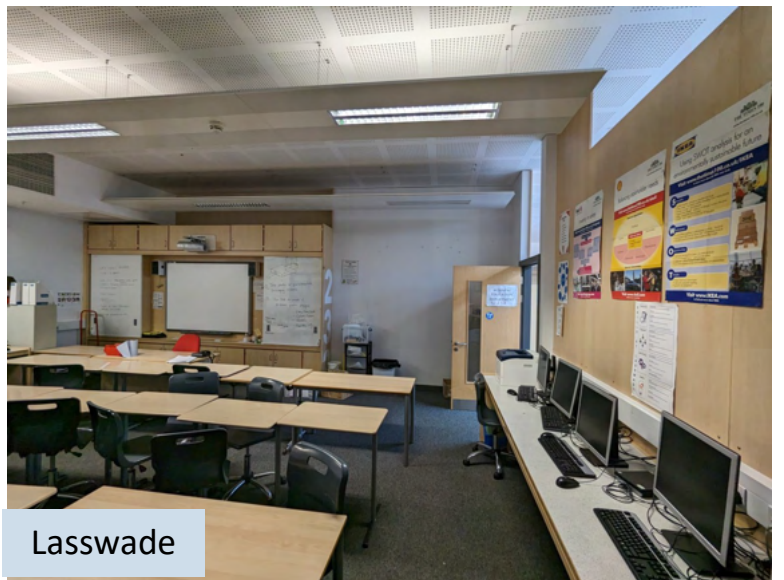
Lasswade

- In two other areas, semi walls were erected post-occupancy (full walls not possible due to ventilation system design constraints) to block out a portion of the sound.

Partial additional walls to block noise (air circulation required)

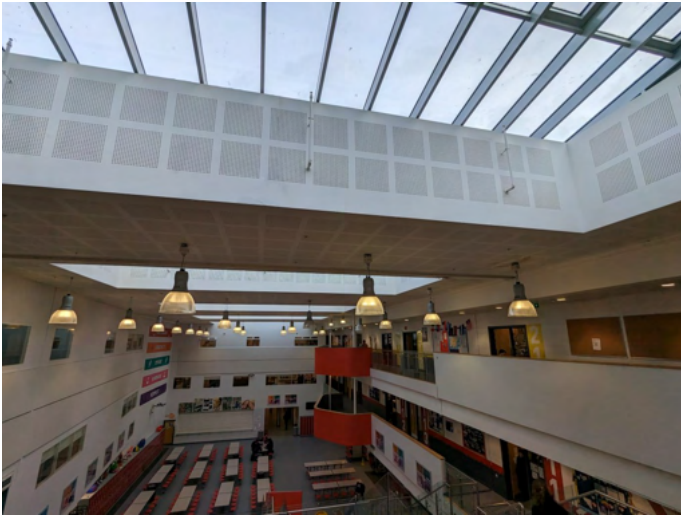
- All classrooms have solid walls and doors, with windows down the side for light.
- Given it was the same architects and opened 11 months after West Calder, we felt the change to remove the full glass walls and replace with partially solid walls in the classrooms was of significance.
- Has some open seating areas – but due to only 50% occupancy these are not used for any timetabled classes. The Head Teacher was surprised this could be considered.
- There was a ‘super lab’ with science lab units on one side and standard desks on the

Bertha Park—partial glass walls

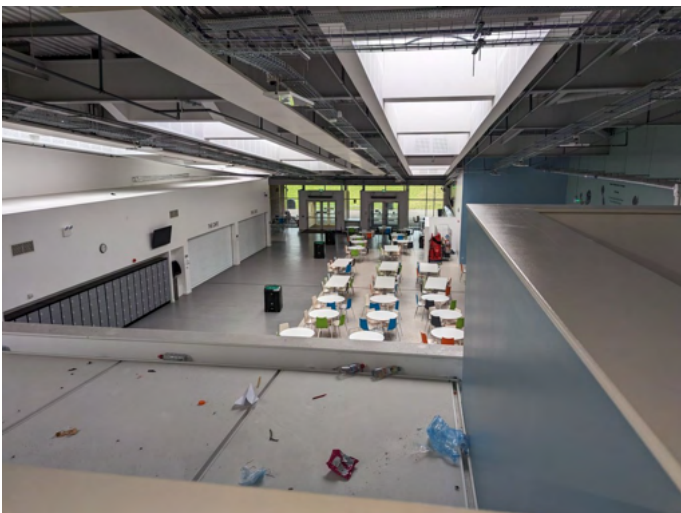
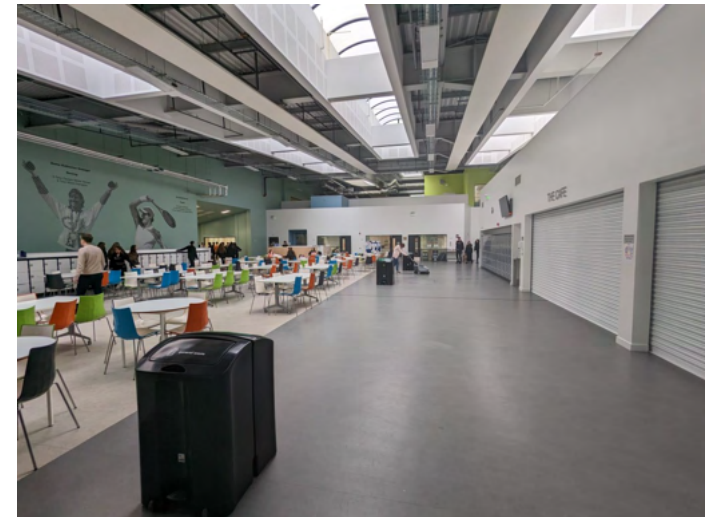
Classroom overlooking Bertha Park dinner hall —partitions used to lessen distraction

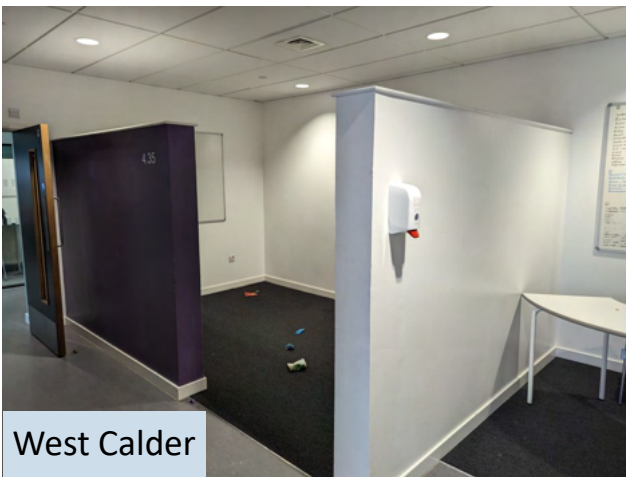
- The rectangular building felt quite curvaceous internally, which had a nice feel but results in some wee nooks and crannies. These were designated as small seating areas – but several have now been blocked off by staff as they had become hidey holes for some students trying to keep out of site. Essentially, a wasted space.

Un-used wee nooks/ study space

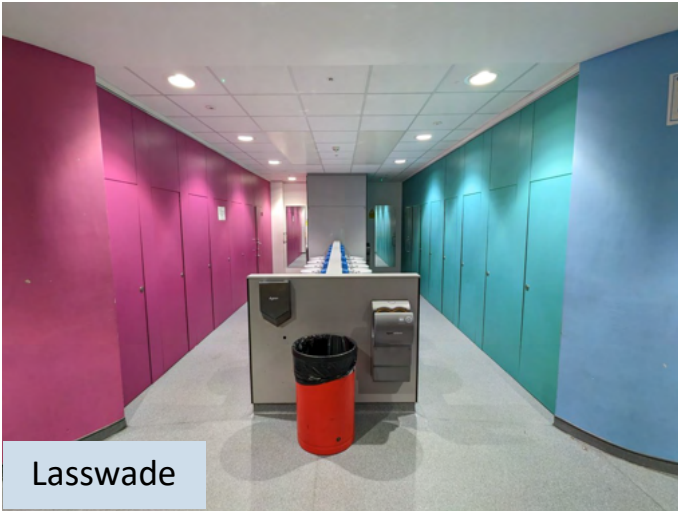
- A mixture of some enclosed toilets plus a large number of cubicles with shared wash facilities – open to the corridors. Noted that the noise from hand-dryers was significant and a real issue for teachers with classes nearby.

Lasswade

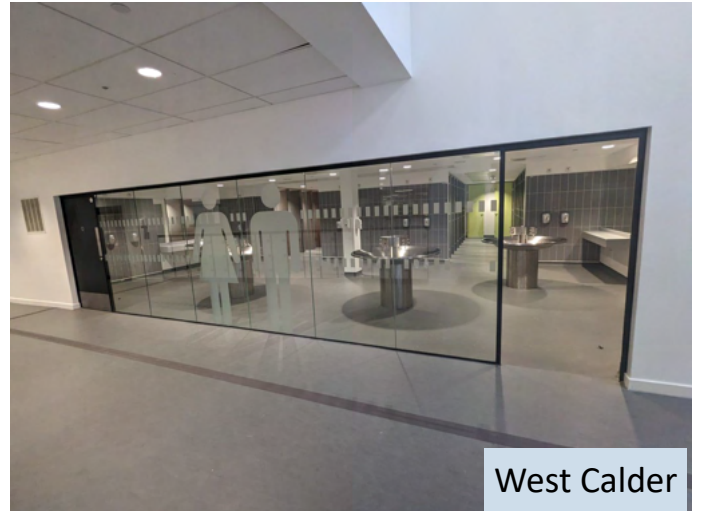
- The toilets were all unisex cubicles, with shared washing facilities. These had glass walls / door to separate them from the corridor and keep noise (e.g. from hand-dryers) down. Seemed to work very well – clean, efficient use of space and flexible use.

West Calder

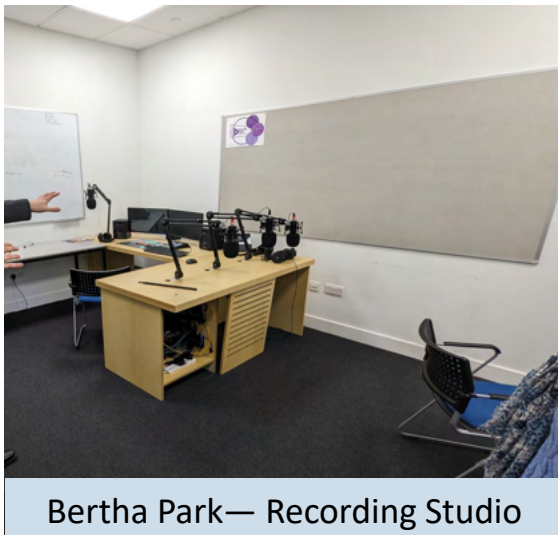
- A recording/broadcast studio had been incorporated into one of the larger music practice rooms – currently being used for a school radio station and recording of podcasts.

Bertha Park— Recording Studio

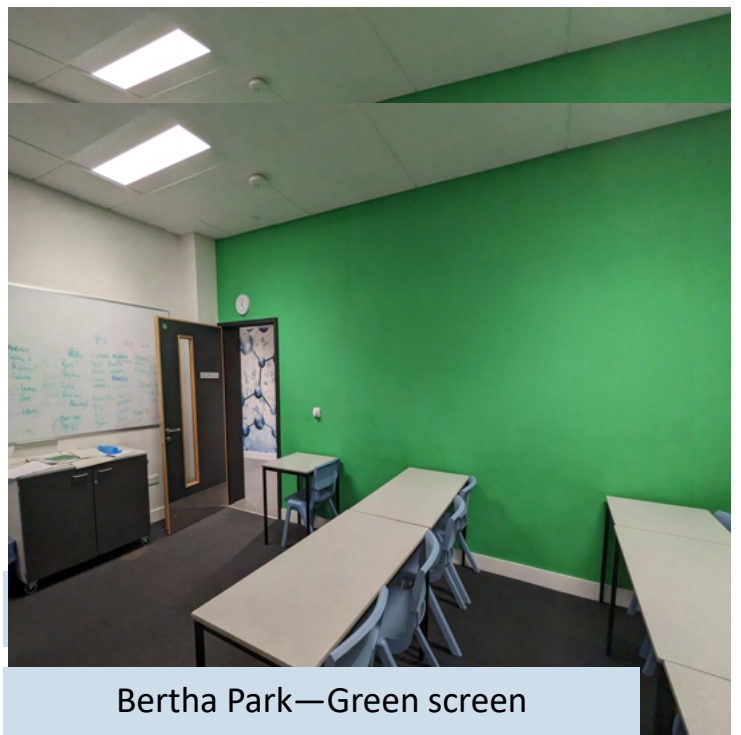
- Use of wood slats in many of the corridors stairs, and assembly hall, was both an acoustic benefit and
- One room on each floor had a whole wall painted bright green – to be a background screen for special effects / videos. A great idea.

Bertha Park—Green screen

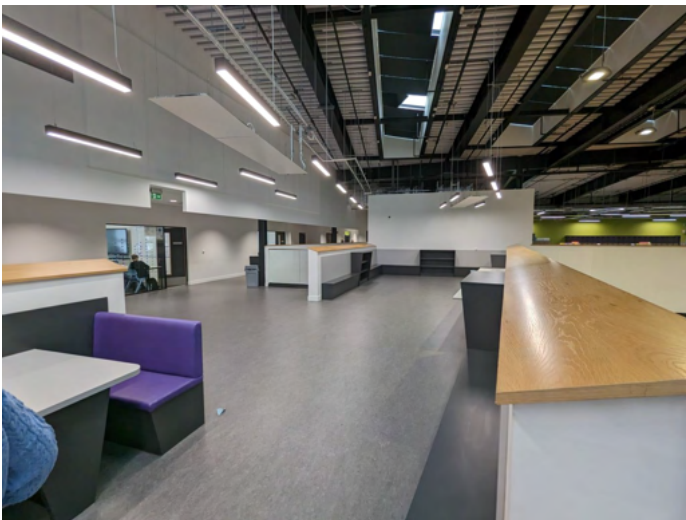
Unused breakout area

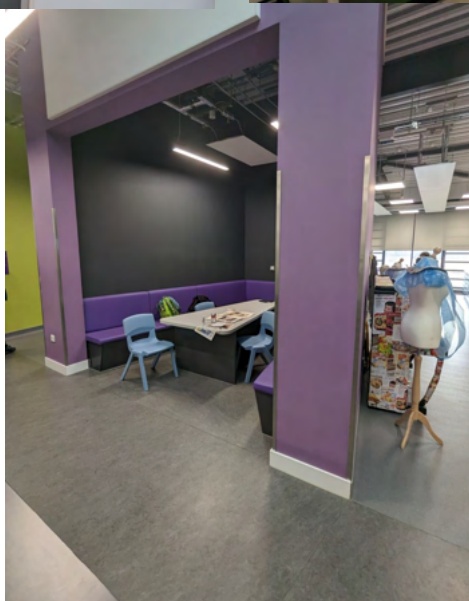
Seat benches too far from table—needed extra chairs

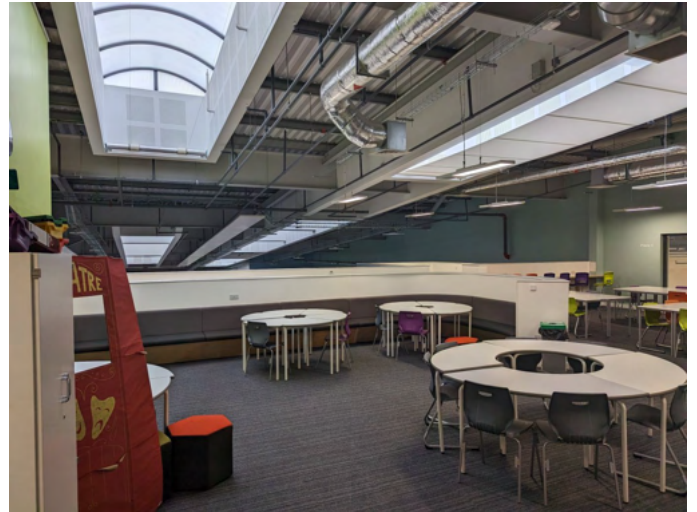
- There were some open break-out areas that were scheduled for use by classes. Walking around while these classes were taking place, it seemed very distracting for the students and required significant effort for the teachers to raise their voices to be heard in these areas. There was a fair bit of background noise – specifically air circulating/machinery/plant, which seemed to emanate from the

Noisy ventilation machinery on roof

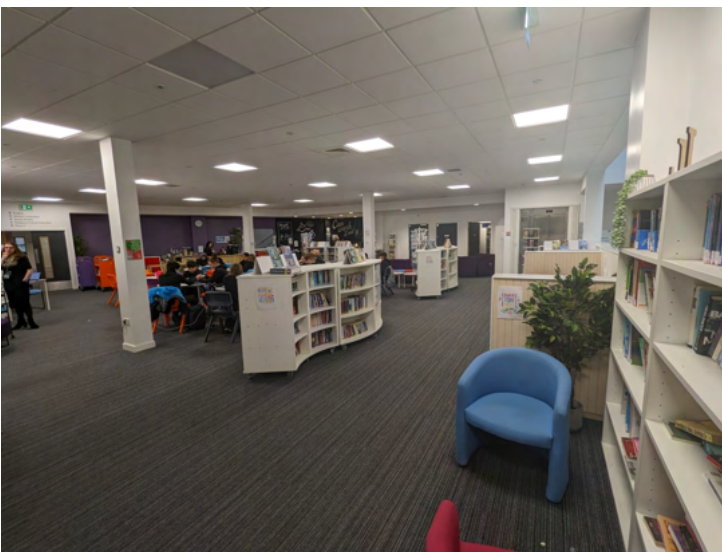
Library & Noisy funnel (PE Corridor)

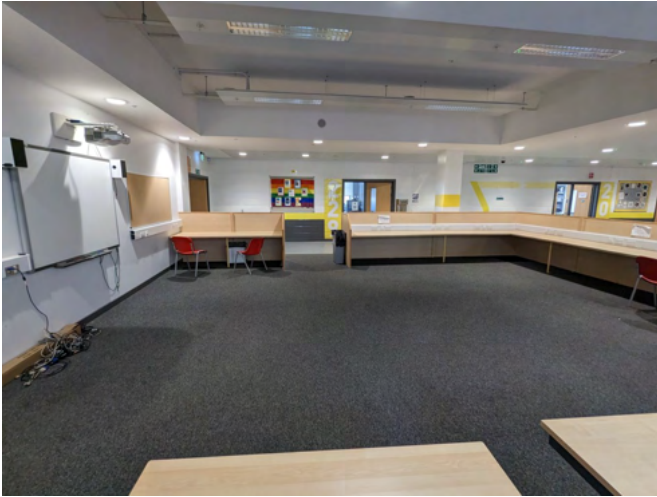
- On one other area, an open plan classroom was no longer in use as a timetabled classroom. It was abandoned and wasted space.
- A number of smaller rooms that had initially been allocated for departmental storage had been taken over for small meeting rooms – the open areas deemed not suitable for private discussion. Therefore departmental storage had been moved into the staff bases (multiple bases throughout the school) which were very full of filing

Unused open area

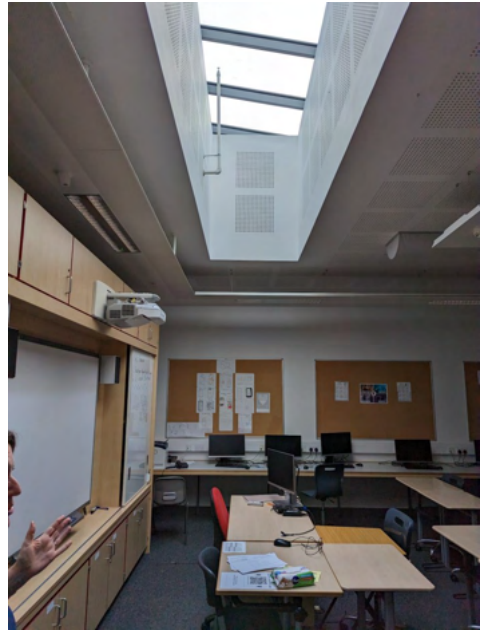
Reflection issues—light above smart board causes problems

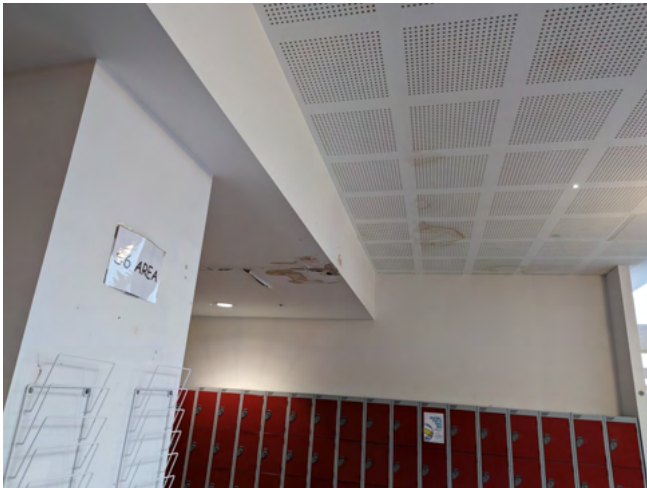
9. Snagging / quality of build –it was evident how much snagging and remedial works had been involved at Lasswade, (also built by BAM). They have had multiple leaks from the roof and pipework and resultant damage. Changing bulbs at a significant height is incredibly difficult and expensive. Recommend getting input from the janitorial staff on general cleaning and maintenance concerns for the new design.

Example of water damage due to leaks
(various issues over the year, only 9 years since new)

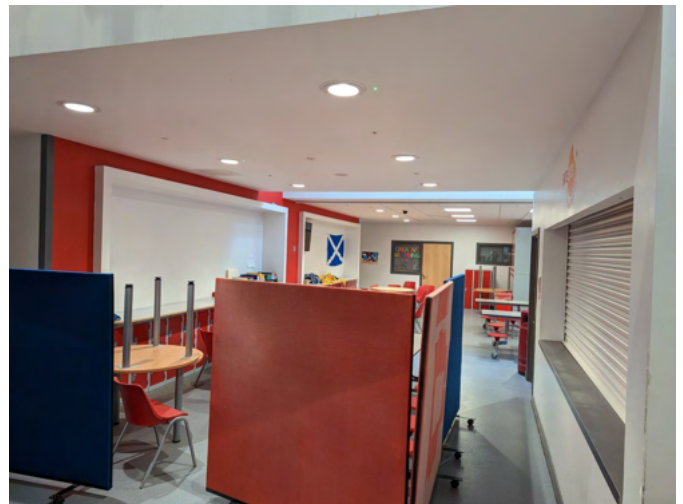
Additional use of temporary and sound and visual barriers in open areas

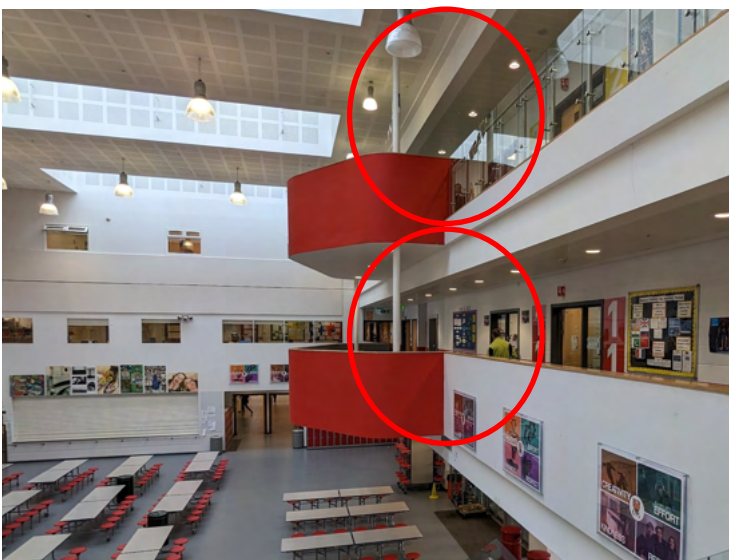
Red Circles show the two new walls, retro-fitted 1 year after opening. These classrooms were open to the atrium area / balcony on initial design

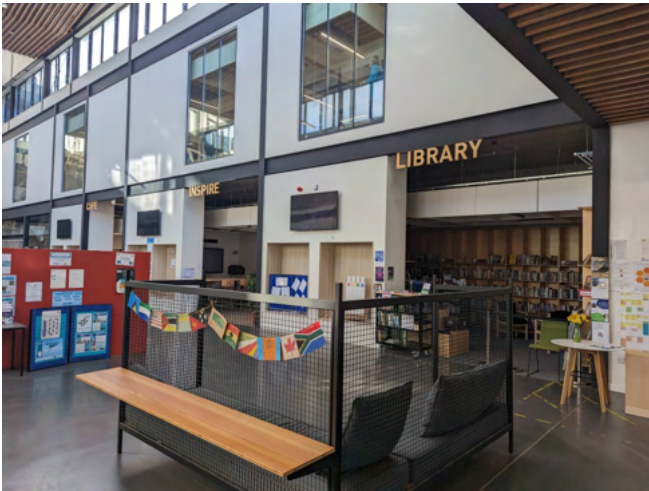
Public library and work/study space accessed from main hall corridor—open and unused.

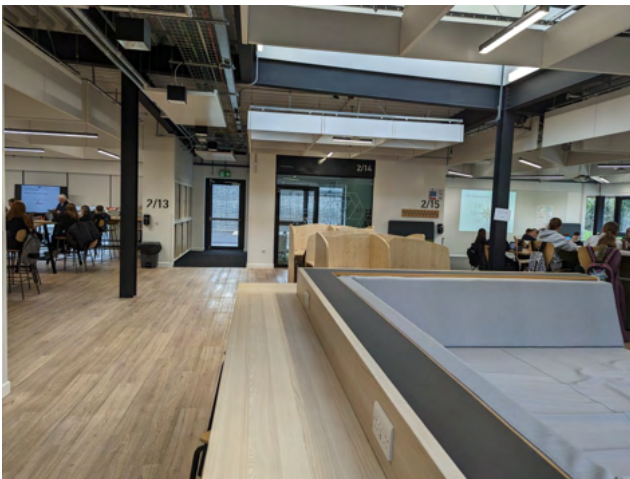
- The majority of classrooms were open-plan to other classrooms and/or break-out spaces. Small group areas for breakout/tutorial activities were a mix of enclosed and open plan, although many small rooms did not have walls right up to the ceiling for ventilation and other services purposes.

Two double classrooms open to each other and a study space and lounge bench

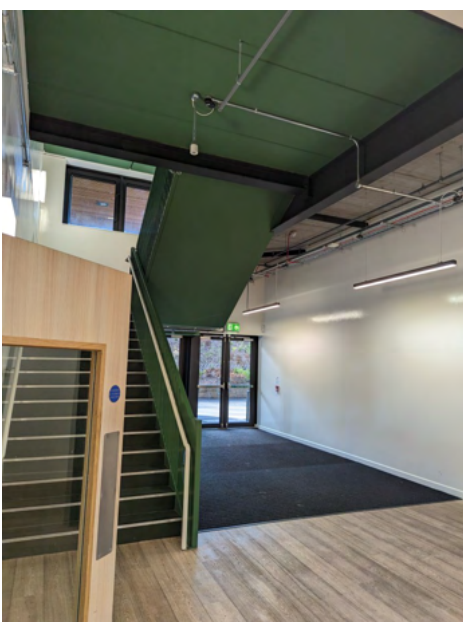
Stairwells—all hard surfaces
